**A study on the use
of Short-Time
Fourier Transform
(STFT) analysis
for track geometry
evaluations
concerning
cyclic irregularities**

Martin Li, Trafikverket
Lars-Ove Jönsson, Analytical Dynamics AB
Sweden

21st Nordic Seminar on Railway Technology
Tampere 21-22 June 2022

Track Geometry Evaluations at Bdl 354

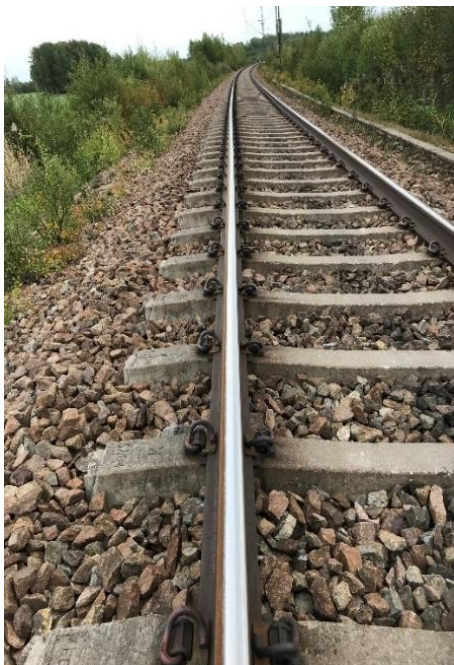
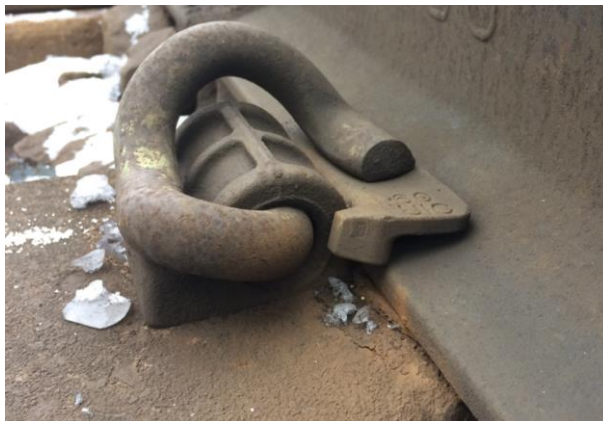
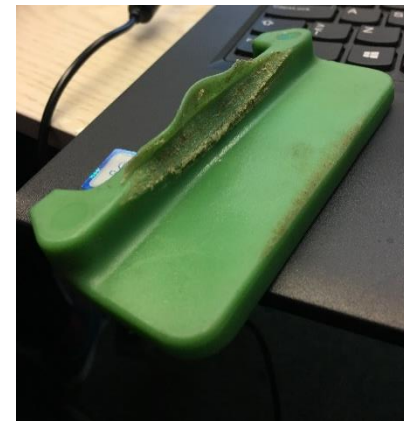
Reports of problems with vehicle vibrations and damaged track components

- **Bdl (Bandel = part of line) 354:**
 - During 2017 and 2018, problems with track geometry and damaged track components were reported repeatedly
 - Problems with vehicle vibrations and damaged suspension systems were also reported
 - Operational speed was reduced from 200 km/h, to 130 km/h and then to 70 km/h.

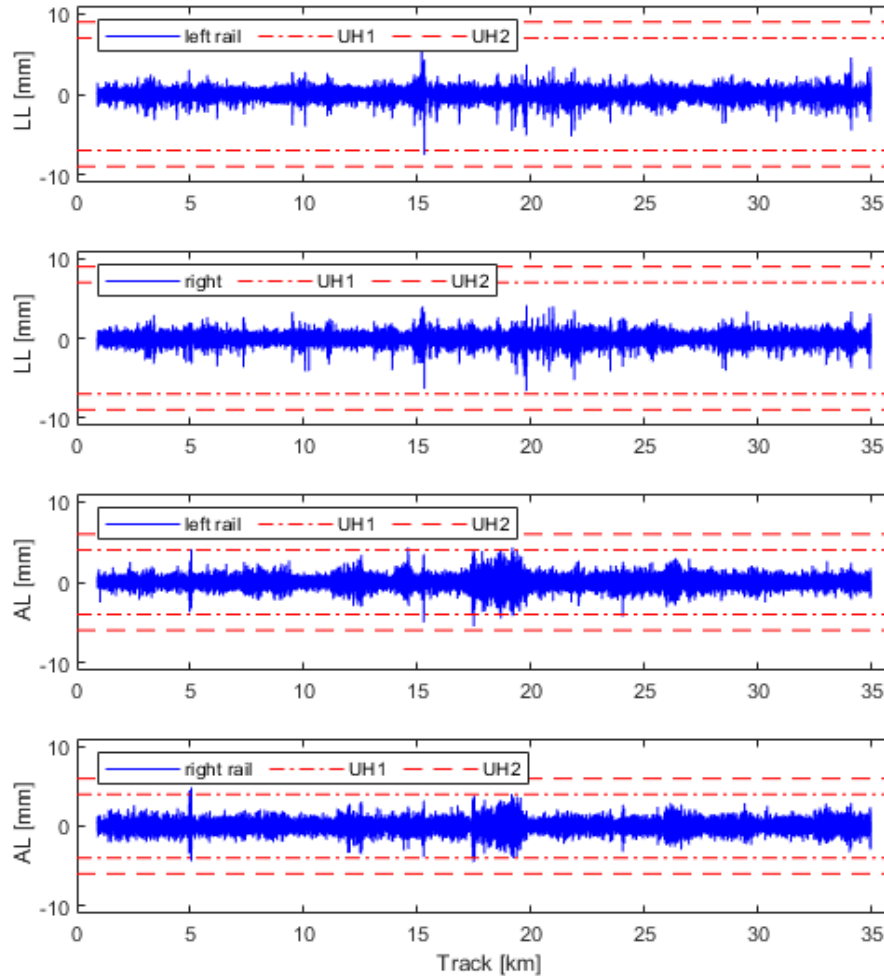
Bdl 354: track irregularities of LL D1 and AL D1 measured 2017-08-30

Most isolated defects are still below the intervention limits (IL) UH1 and UH2

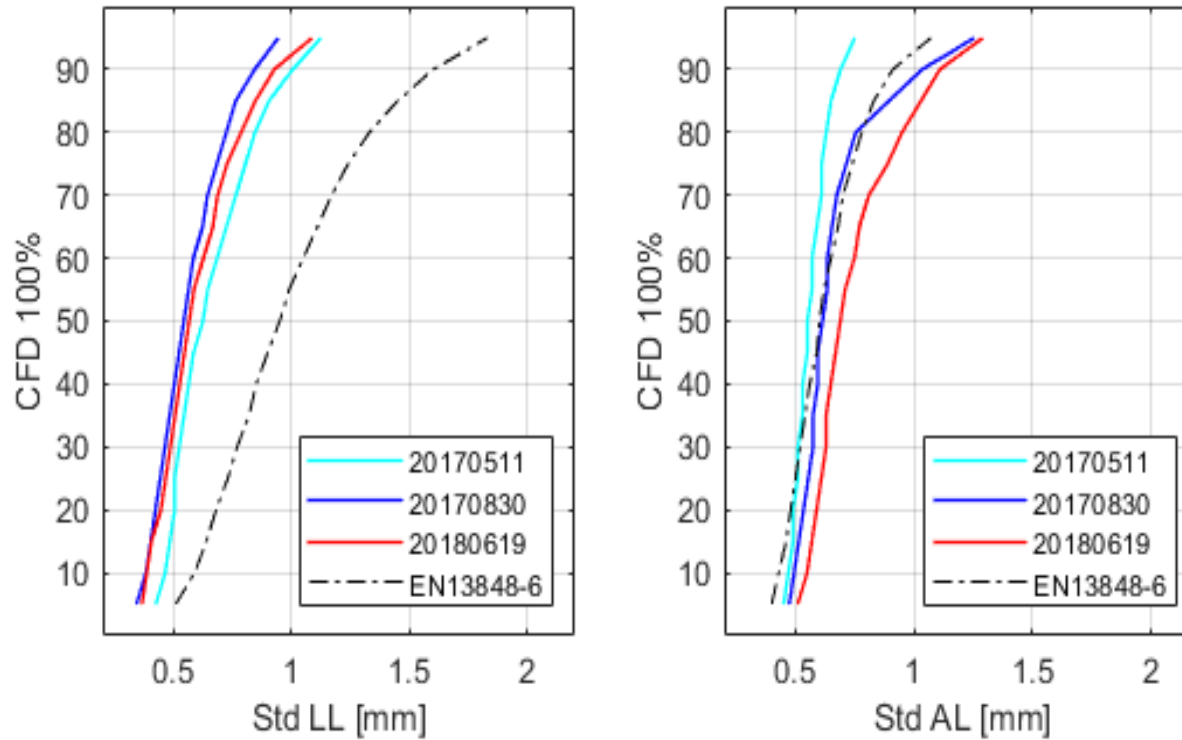
Bdl 354: Cumulative Frequency Distributions (CFD) of standard deviation

- 2017-05-11: the CFD curve for AL was still mostly lower than reference curve
- 2018-06-19: the CFD curve for AL was completely higher than reference curve

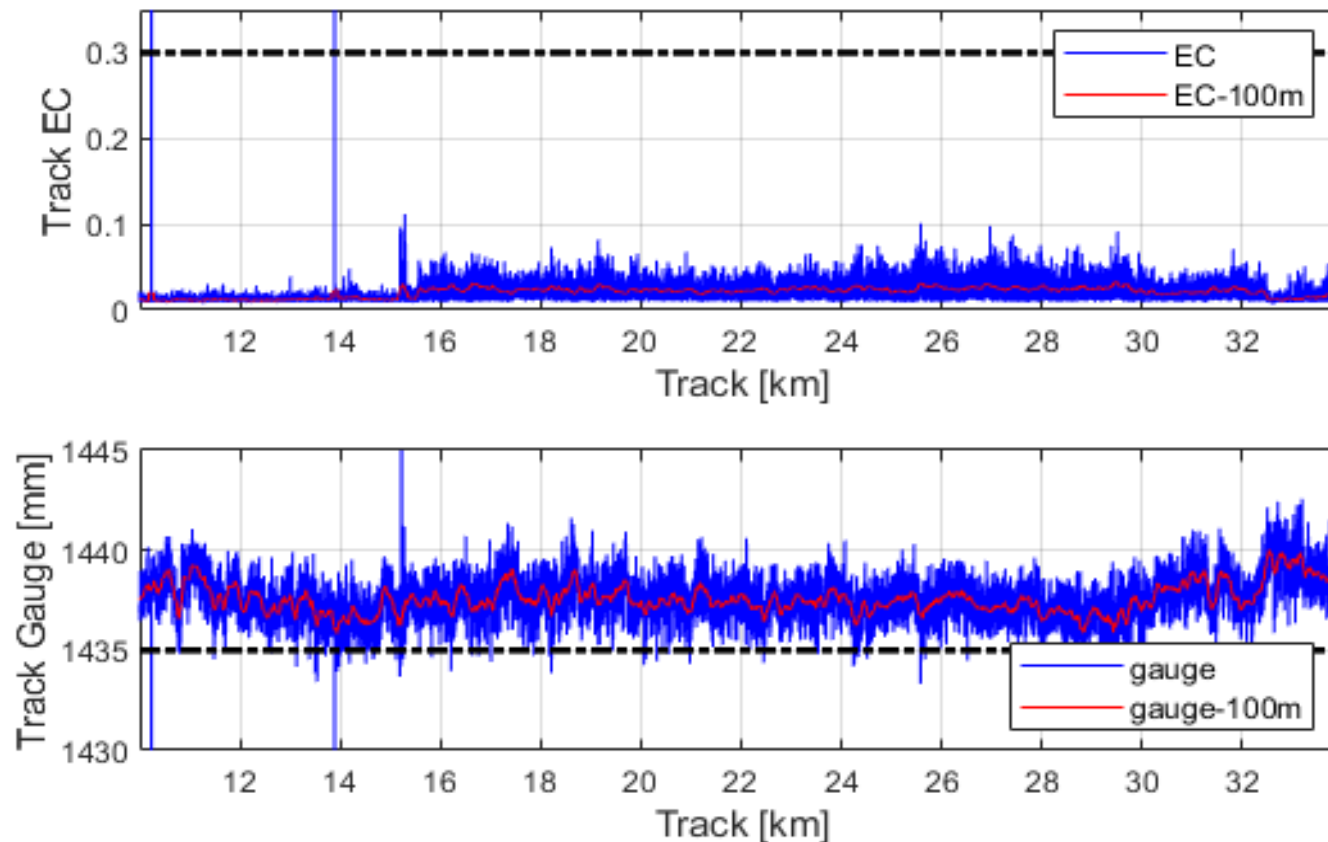
Track Equivalent conicity and track gauge 2017-08-30 -> **OK!**

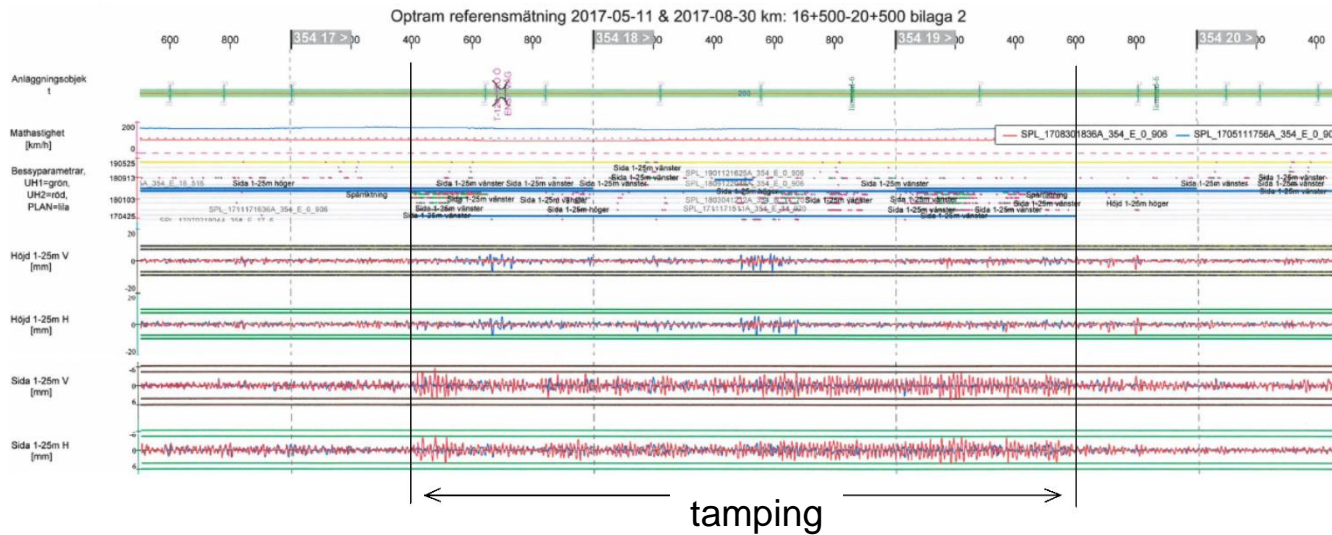
What caused the problems?

A combination of track and vehicle issues:

- Track tamping without sufficient stabilisation
- Unrelated: hunting instability due to maintenance issues
