**A study on the use
of Short-Time
Fourier Transform
(STFT) analysis
for track geometry
evaluations
concerning
cyclic irregularities**

Martin Li, Trafikverket
Lars-Ove Jönsson, Analytical Dynamics AB
Sweden

21st Nordic Seminar on Railway Technology
Tampere 21-22 June 2022

Track Geometry Evaluations at Bdl 354

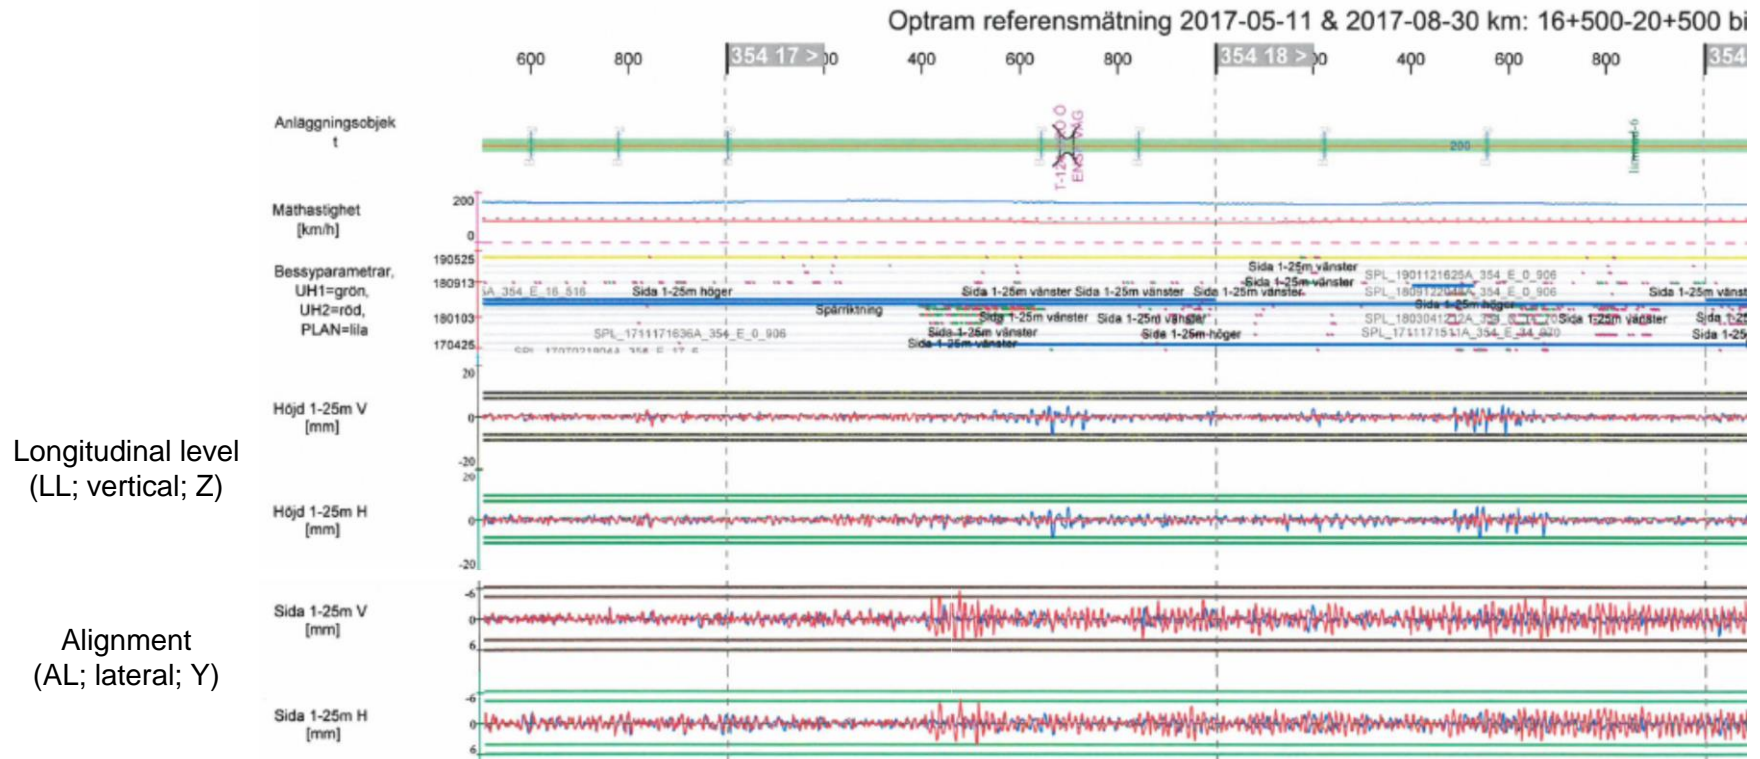
Two consecutive track measurements: 2017-05-11 and 2017-08-30

- **Bdl (Bandel = part of line) 354:**
 - During 2017 and 2018, problems with track geometry and damaged track components were reported repeatedly
 - Problems with vehicle vibrations and damaged suspension systems were also reported
 - Operational speed was reduced from 200 km/h, to 130 km/h and then to 70 km/h.
